# Manhole Inspection Summary

Manhole # S37GG1026MH

Insp Date: **1/9/07 2:08 PM**

**Location** Address: **3916 OLD YORK RD**

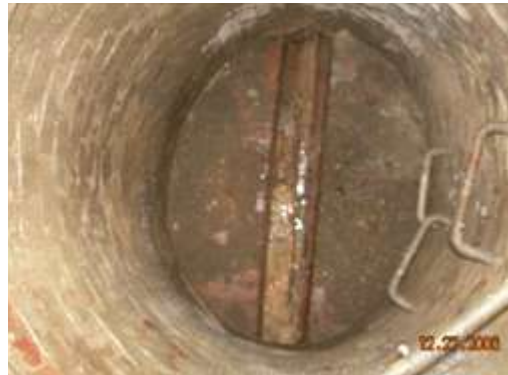
Top View

**Bench** ☒ Exists Material: **Brick** ☐ Parged ☒ **Debris** (not Condition related)

**Channel** Material: **Brick** ☐ Parged ☒ **Debris** (not Condition related)

**Steps** Count: **4** Missing: **0** ☒ **Corroded**

**Surcharge** ☒ **Evidence Of Surcharge** Depth: **1** (ft.) ☐ Active Surcharge Present

Corroded steps. Evidence of surcharge - Bench debris. Channel debris.

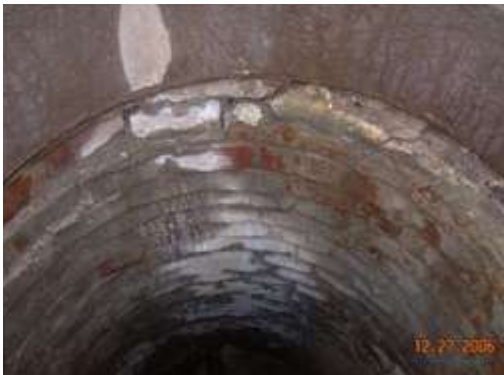
Defect

**Frame** Offset: **1** (in.) Condition: ☐ Sound ☐ Cracked ☒ **Leaks**

Condition: ☐ Sound ☐ Cracked ☐ Root Intrusion ☐ Loose Brick ☒ **Deteriorated**

Infiltration: ☐ None ☒ **Joint** ☐ Cracks ☐ Mortar ☐ Roots ☒ **Wall**

Infiltration: ☐ None ☐ Joint ☐ Cracks ☐ Mortar ☐ Roots ☒ **Wall**

Frame leaks. Corbel deterioration and infiltration. Barrel infiltration.

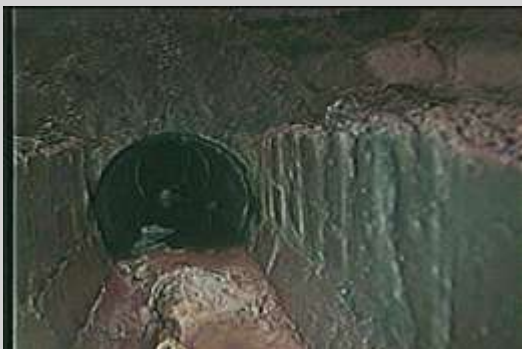
### 8 in. Circular Gravity Sewer Pipe In @ 6 O'Clock

Condition: ☐ Sound ☐ Cracked ☐ Root Intrusion ☒ **Deteriorated** ☐ Leaks ☐ Debris

Channel deterioration.

Deposits: ☐ None ☐ Mud ☐ Sludge ☒ Debris ☒ Grease

Silt Depth: **1** (in.) Deposits Extent: **Light**
